Project**Project Name:** ARRIVA ST HELENS JN-CW-7734**Project Date:** 01/07/2025**Inspection Standard:** MSCC5 Sewers & Drainage GB (SRM5 Scoring)

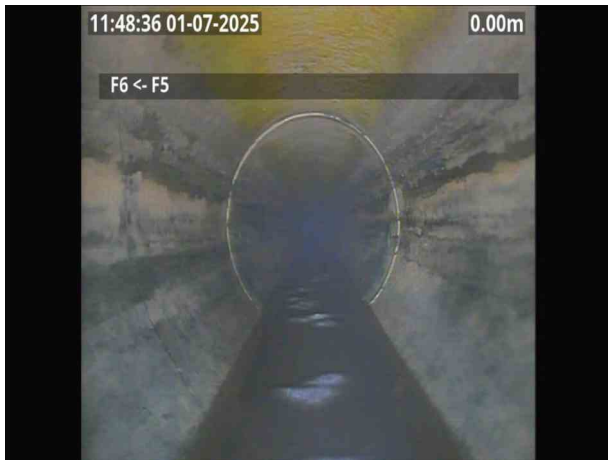
F6X_6f4d11eb-525f-4dc1-817c-110dd92e14c7_20250701_115932_570.jpg, 00:00:09, 0.10 m
Fracture, circumferential from 7 o'clock to 11 o'clock

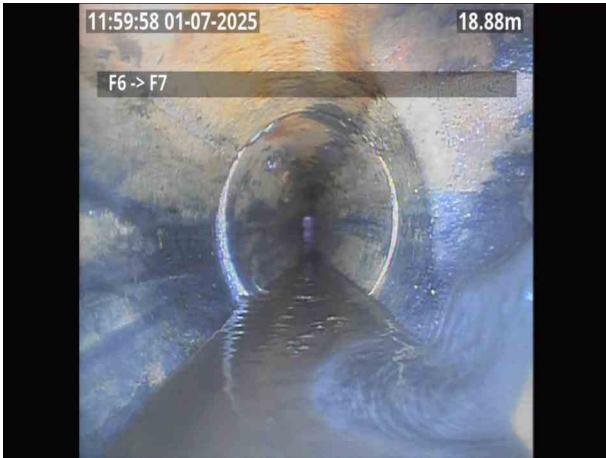
F6X_5573d4ed-00ff-41a9-92a9-bb417d6eddd2_20250707_10
5757_261.jpg, 00:02:09, 18.90 m
Junction at 2 o'clock, 100mm dia, OIL SEEPING FROM
JUNCTION

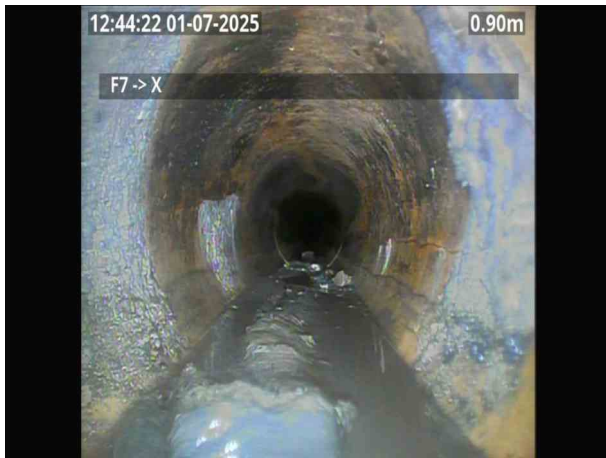
F7X_2cebb3cf-ce4d-48ab-a9af-d0640c6c402a_20250701_125518_818.jpg, 00:00:18, 0.90 m
Attached deposits, encrustation at joint from 6 o'clock to 4 o'clock, 10% cross-sectional area loss

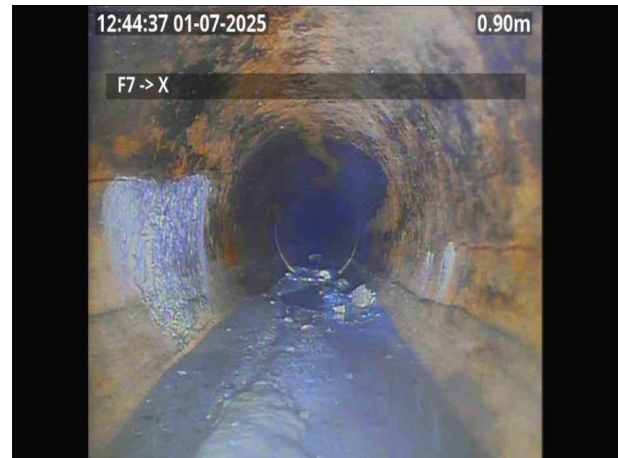
| Scale: 1:597 | Position [m] | Code | Observation | MPEG | Photo | Grade |
|---|---|---|---|---|---|---|
| FL | Fracture, longitudinal at 3 o'clock | | 00:00:26 | F7X_e866 e143-6df4-4900-a2e6 | 3 / 2 | |

F7X_e866e143-6df4-4900-a2e6-2bbadc6be201_20250701_125533_625.jpg, 00:00:26, 0.90 m
Fracture, longitudinal at 3 o'clock

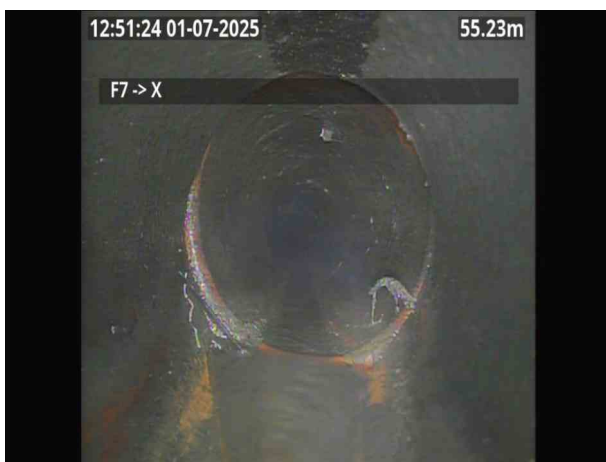
| Scale: 1:597 | Position [m] | Code | Observation | MPEG | Photo | Grade |
|---|---|---|---|---|---|---|
| BJ | Broken pipe at joint from 5 o'clock to 7 o'clock | | 00:06:56 | F7X_2b78 a31f-4bd2-423a-b797 | 4 | |

F7X_2b78a31f-4bd2-423a-b797-2f050bc601a7_20250701_130220_558.jpg, 00:06:56, 55.20 m
Broken pipe at joint from 5 o'clock to 7 o'clock

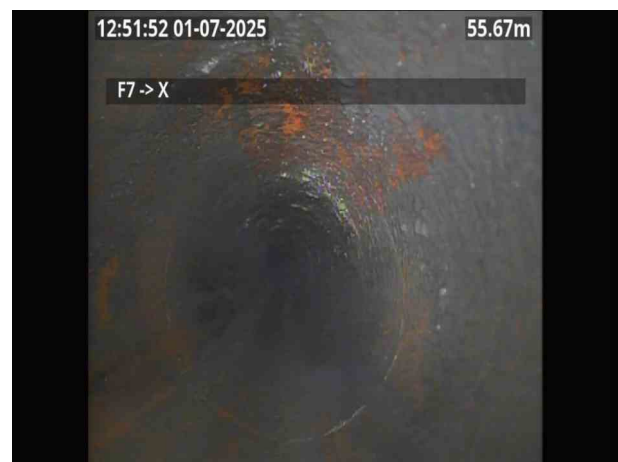
| Scale: 1:597 | Position [m] | Code | Observation | MPEG | Photo | Grade |
|---|---|---|---|---|---|---|
| CC | Crack, circumferential from 2 o'clock to 10 o'clock | | 00:07:25 | F7X_1ef5a f32-a849-4c28-9d9b- | 2 / 2 | |

F7X_1ef5af32-a849-4c28-9d9b-125c606dfdfa_20250707_113330_364.jpg, 00:07:25, 55.70 m
Crack, circumferential from 2 o'clock to 10 o'clock

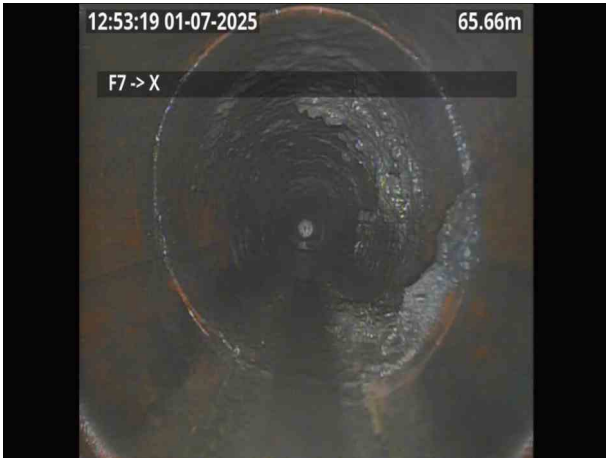
| Scale: 1:597 | Position [m] | Code | Observation | MPEG | Photo | Grade |
|---|---|---|---|---|---|---|
| FC | Fracture, circumferential from 7 o'clock to 5 o'clock | | 00:08:53 | F7X_9e97 74fc-d7c8-4a71-993b | 3 / 2 | |

F7X_9e9774fc-d7c8-4a71-993b-95ff7dae50c2_20250707_113
517_940.jpg, 00:08:53, 65.66 m
Fracture, circumferential from 7 o'clock to 5 o'clock

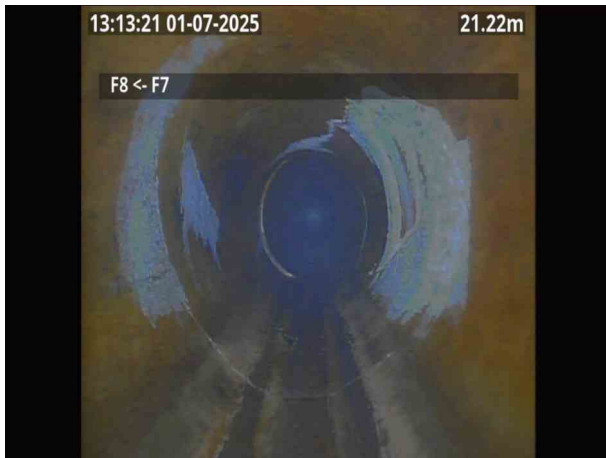
| Scale: | 1:198 | Position [m] | Code | Observation | MPEG | Photo | Grade |
|---|---|---|---|--|---|---|---|
| | | 21.31 | FC | Fracture, circumferential from 4 o'clock to 11 o'clock | 00:03:07 | F8X_60b6 ea5c-6835 -4b66-8df7 | 3 / 2 |

F8X_60b6ea5c-6835-4b66-8df7-946466924d2d_20250707_1
15901_741.jpg, 00:03:07, 21.31 m
Fracture, circumferential from 4 o'clock to 11 o'clock

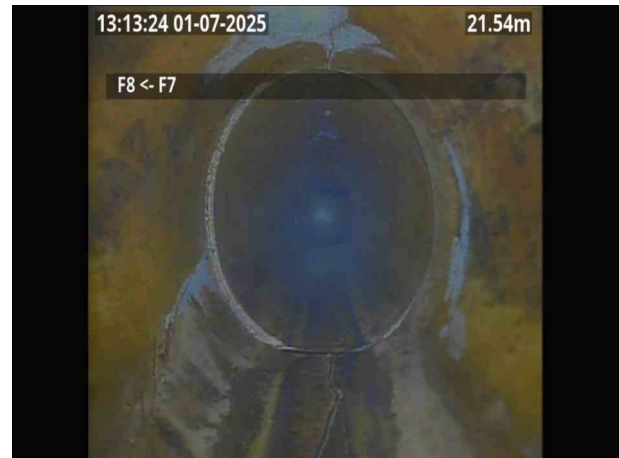
| Scale: | 1:198 | Position [m] | Code | Observation | MPEG | Photo | Grade |
|---|---|---|---|--|---|---|---|
| | | 21.57 | FL | Fracture, longitudinal at 6 o'clock | 00:03:10 | F8X_bccc a670-a999 -44fb-9e4f- | 3 / 2 |

F8X_bccca670-a999-44fb-9e4f-6c7234ca2b9b_20250707_11
5919_097.jpg, 00:03:10, 21.57 m
Fracture, longitudinal at 6 o'clock

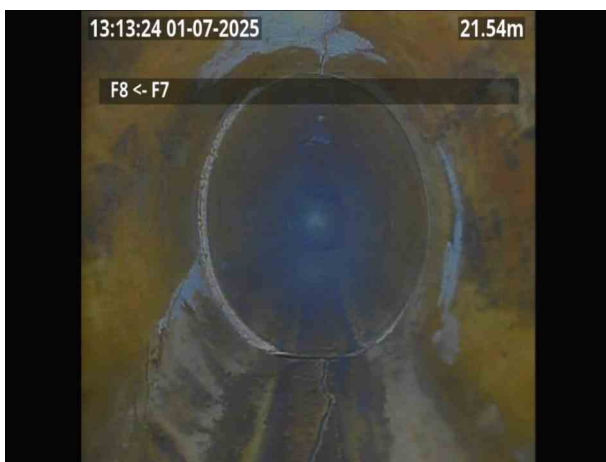
| Scale: | 1:198 | Position [m] | Code | Observation | MPEG | Photo | Grade |
|---|---|---|---|--|---|---|---|
| | | 21.57 | FS | Fracture, spiral from 7 o'clock to 8 o'clock | 00:03:10 | F8X_5d12 dc2e-1556 -44b6-b0f8 | 4 / 2 |

F8X_5d12dc2e-1556-44b6-b0f8-dfa69c4243bc_20250707_11
5937_632.jpg, 00:03:10, 21.57 m
Fracture, spiral from 7 o'clock to 8 o'clock

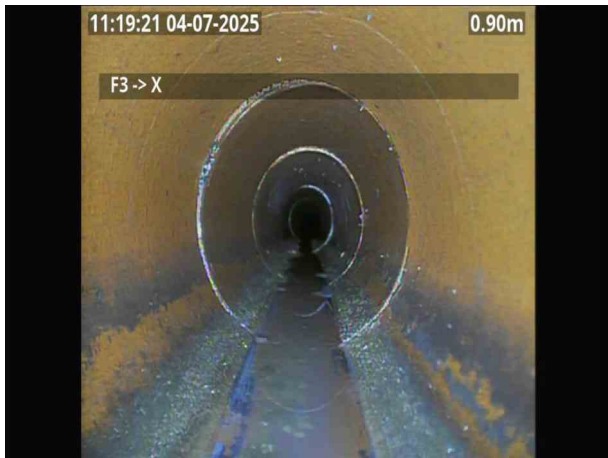
| Scale: | 1:289 | Position [m] | Code | Observation | MPEG | Photo | Grade |
|---|---|---|--|---|---|---|---|
| | 0.90 | CC | Crack, circumferential from 9 o'clock to 3 o'clock | | 00:00:21 | F3X_9614 26f9-a001- 4769-bea9 | 2 / 2 |

F3X_961426f9-a001-4769-bea9-90aeee7a0536_20250704_13021_277.jpg, 00:00:21, 0.90 m
Crack, circumferential from 9 o'clock to 3 o'clock

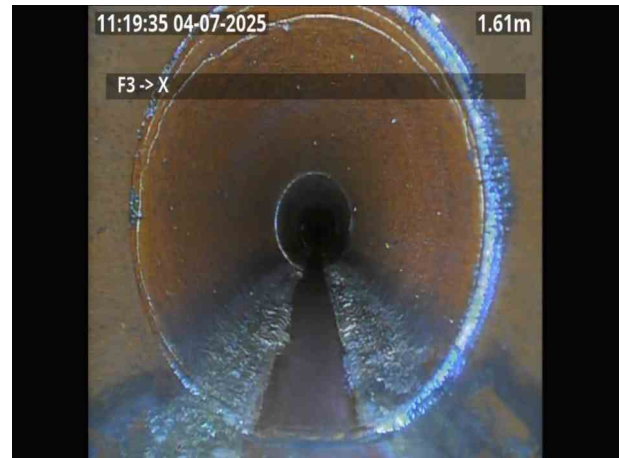
| Scale: | 1:289 | Position [m] | Code | Observation | MPEG | Photo | Grade |
|---|---|---|--|---|---|---|---|
| | 1.68 | FCJ | Fracture, circumferential at joint from 9 o'clock to 3 o'clock | | 00:00:36 | F3X_5403 d241-f452- 4c07-aec5 | 3 / 2 |

F3X_5403d241-f452-4c07-aec5-fb3d217b923b_20250707_120216_507.jpg, 00:00:36, 1.68 m
Fracture, circumferential at joint from 9 o'clock to 3 o'clock

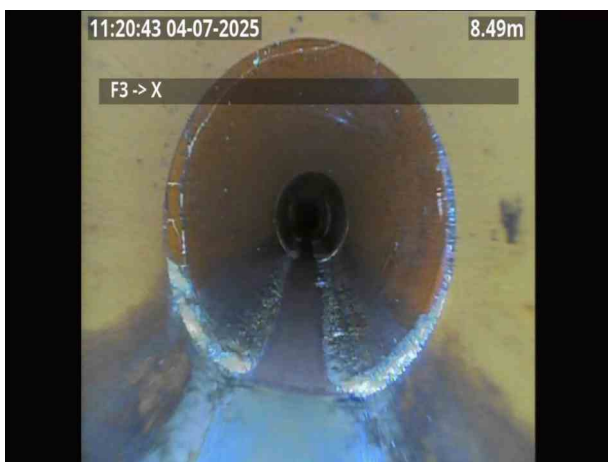
| Scale: | 1:289 | Position [m] | Code | Observation | MPEG | Photo | Grade |
|---|---|---|--|---|---|---|---|
| | 8.49 | CCJ | Crack, circumferential at joint from 8 o'clock to 12 o'clock | | 00:01:34 | F3X_bde3 0e6a-650f- 4065-b883 | 2 / 2 |

F3X_bde30e6a-650f-4065-b883-f7b918a07475_20250707_120507_271.jpg, 00:01:34, 8.49 m
Crack, circumferential at joint from 8 o'clock to 12 o'clock

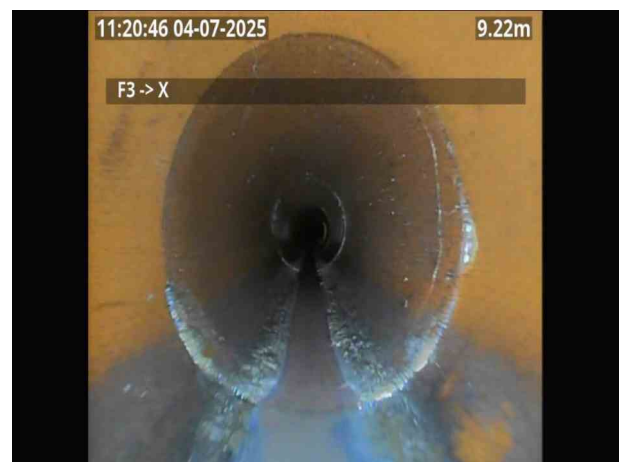
| Scale: | 1:289 | Position [m] | Code | Observation | MPEG | Photo | Grade |
|---|---|---|--|---|---|---|---|
| | 9.21 | CLJ | Crack, longitudinal at joint at 11 o'clock | | 00:01:36 | F3X_2e39 e058-68f0- 44c6-aecb | 2 / 2 |

F3X_2e39e058-68f0-44c6-aecb-a4a7b49ea403_20250707_120543_999.jpg, 00:01:36, 9.21 m
Crack, longitudinal at joint at 11 o'clock

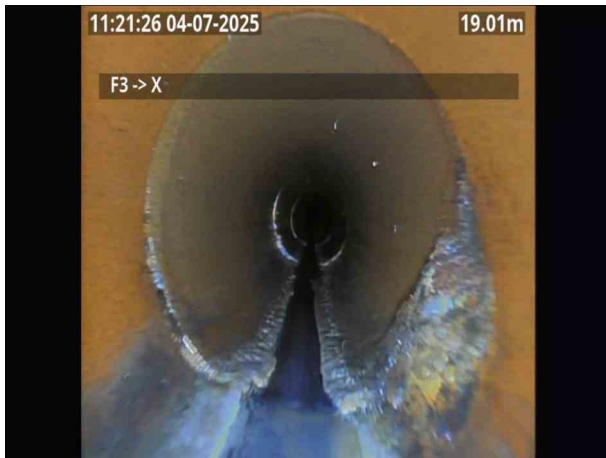
F3X_38cab818-b850-46f9-b7d4-967a63ccb544_20250707_120644_892.jpg, 00:02:17, 19.03 m
Attached deposits, encrustation at joint from 3 o'clock to 5 o'clock, 10% cross-sectional area loss

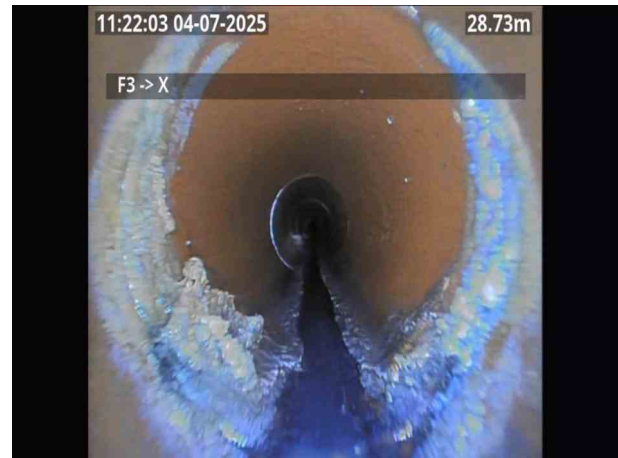
F3X_b7029ac4-ffbb-4223-847e-aea42a170885_20250707_122521_263.jpg, 00:02:54, 28.75 m
Attached deposits, encrustation at joint from 2 o'clock to 10 o'clock, 10% cross-sectional area loss

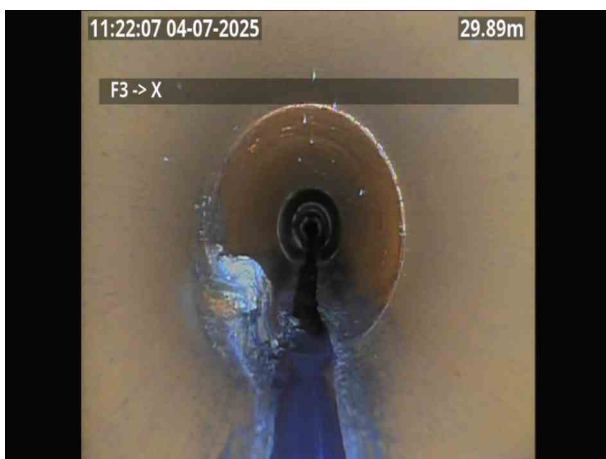
F3X_189214a9-834c-457e-bb3e-cfd1ea22abb_20250707_123144_989.jpg, 00:02:58, 29.89 m
Attached deposits, encrustation at joint from 6 o'clock to 8 o'clock, 20% cross-sectional area loss

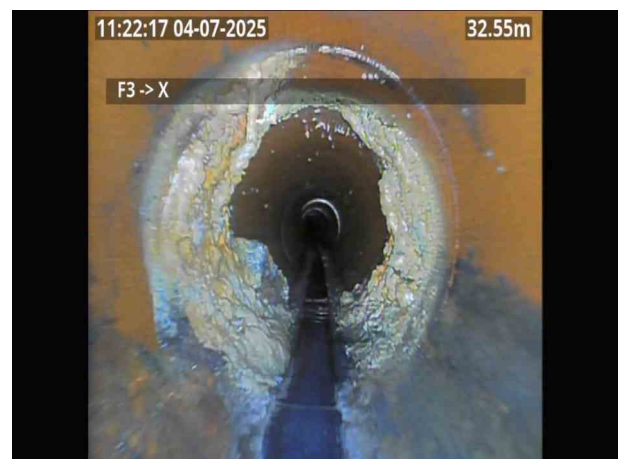
F3X_8a7aee5a-8aa3-4003-8aa6-36698937b613_20250707_125243_301.jpg, 00:03:08, 32.57 m
Attached deposits, encrustation at joint from 12 o'clock to 12 o'clock, 35% cross-sectional area loss

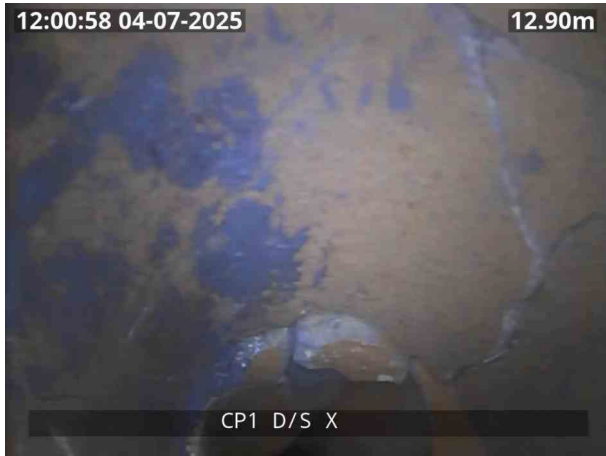
| Scale: | 1:116 | Position [m] | Code | Observation | MPEG | Photo | Grade |
|---|---|---|---|--|---|---|---|
| | | 12.90 | FM | Fractures, multiple from 12 o'clock to 12 o'clock | 00:01:05 | CP1X_247 23964-6d2 1-408b-b0 | 4 / 2 |

CP1X_24723964-6d21-408b-b0ca-30731111240d_20250709_160436_902.jpg, 00:01:05, 12.90 m
Fractures, multiple from 12 o'clock to 12 o'clock

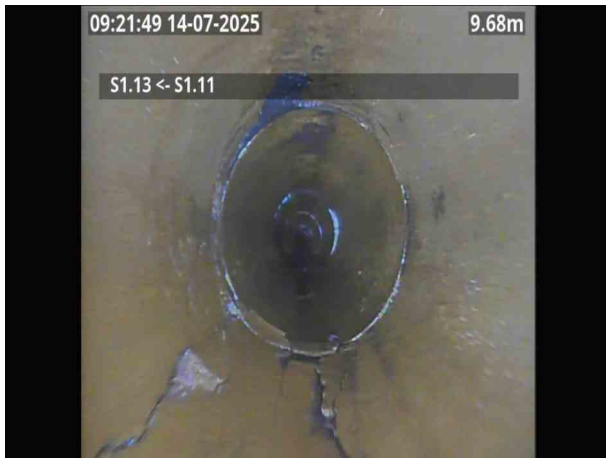
| Scale: | 1:504 | Position [m] | Code | Observation | MPEG | Photo | Grade |
|--|---|---|--|---|---|---|---|
| | 9.76 | FL | Fracture, longitudinal at 6 o'clock | 00:00:53 | S1.13X_d7 18a536-31 e4-46e8-b | 3 / 2 | |

S1.13X_d718a536-31e4-46e8-bb4f-156a2cad05c7_20250715_132109_532.jpg, 00:00:53, 9.76 m
Fracture, longitudinal at 6 o'clock

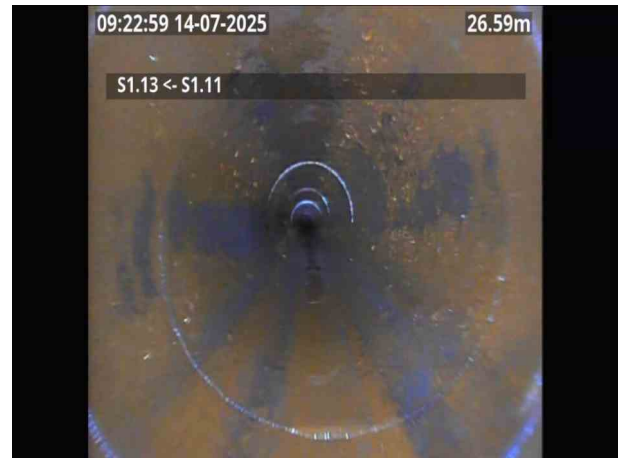
| Scale: | 1:504 | Position [m] | Code | Observation | MPEG | Photo | Grade |
|--|---|---|--|---|---|---|---|
| | 26.61 | FCJ | Fracture, circumferential at joint from 2 o'clock to 9 o'clock | 00:02:03 | S1.13X_e2 04bb02-98 75-4ed0-a | 3 / 2 | |

S1.13X_e204bb02-9875-4ed0-a359-01c3a86236f2_20250715_132329_615.jpg, 00:02:03, 26.61 m
Fracture, circumferential at joint from 2 o'clock to 9 o'clock

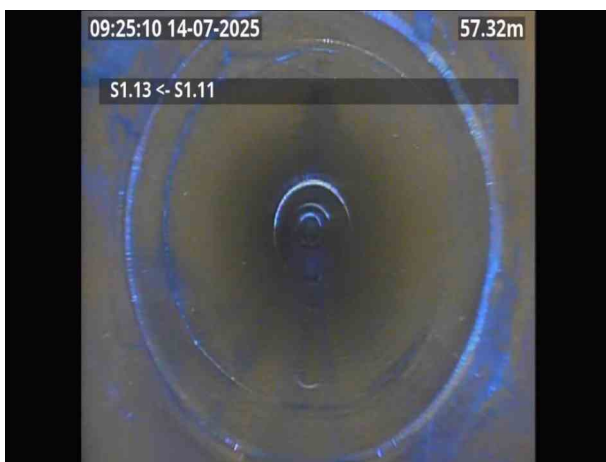
| Scale: | 1:504 | Position [m] | Code | Observation | MPEG | Photo | Grade |
|--|---|---|--|---|---|---|---|
| | 57.33 | FCJ | Fracture, circumferential at joint from 5 o'clock to 2 o'clock | 00:04:13 | S1.13X_3d 42556b-dd 6c-4ab5-b | 3 / 2 | |

S1.13X_3d42556b-dd6c-4ab5-b3a2-4e8464f05179_20250715_132704_236.jpg, 00:04:13, 57.33 m
Fracture, circumferential at joint from 5 o'clock to 2 o'clock

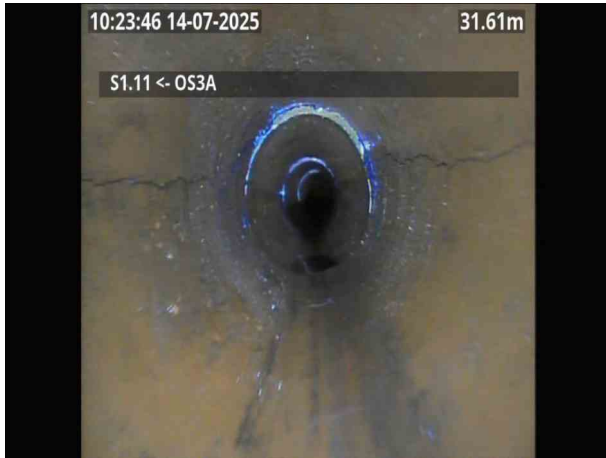
<table><tr><th>Position [m]</th><th>Code</th><th>Observation</th><th>MPEG</th><th>Photo</th><th>Grade</th></tr><tr><td>31.62</td><td>FL</td><td>Fracture, longitudinal at 10 o'clock</td><td>00:02:29</td><td>S1.11X_de 94bae1-0c 39-4e9c-b</td><td>3 / 2</td></tr></table>

S1.11X_de94bae1-0c39-4e9c-b2cc-bd90c84e7fed_20250715_133246_279.jpg, 00:02:29, 31.62 m
Fracture, longitudinal at 10 o'clock

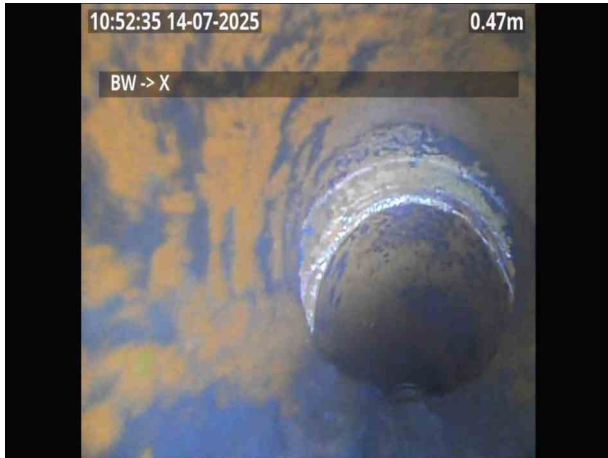
BWX_10a2d309-bf9d-4a8d-950a-84363a479038_20250715_133735_235.jpg, 00:00:21, 0.66 m
Joint displaced, large

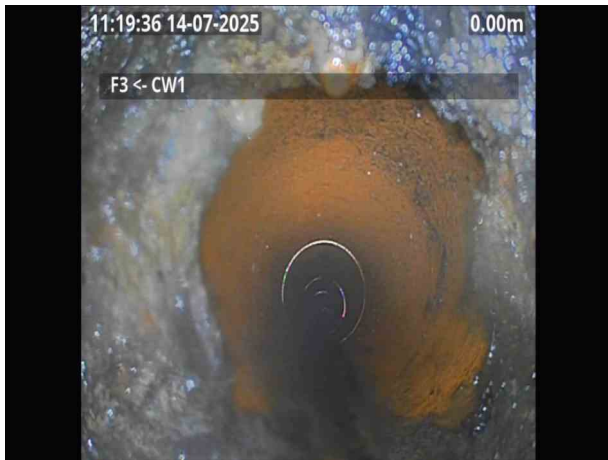
F3X_5799ba64-98ef-4d39-a45d-4d5303f33a3a_20250715_133820_506.jpg, 00:00:04, 0.00 m

Attached deposits, encrustation from 12 o'clock to 12 o'clock,
20% cross-sectional area loss

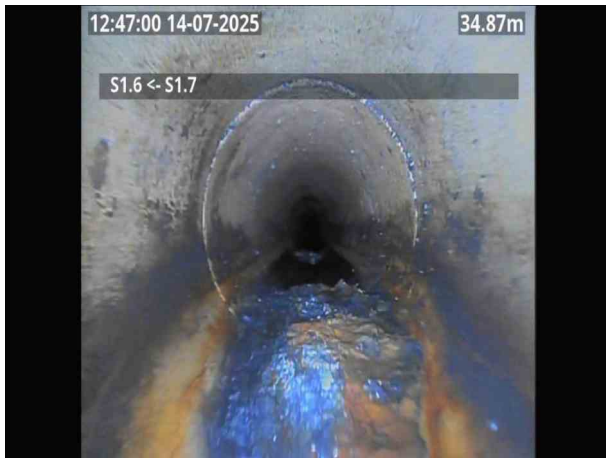
S1.6X_66bce885-8676-48f8-a509-218a3099b25c_20250715_134325_332.jpg, 00:02:42, 34.93 m
Settled deposits, hard or compacted, 20% cross-sectional area loss

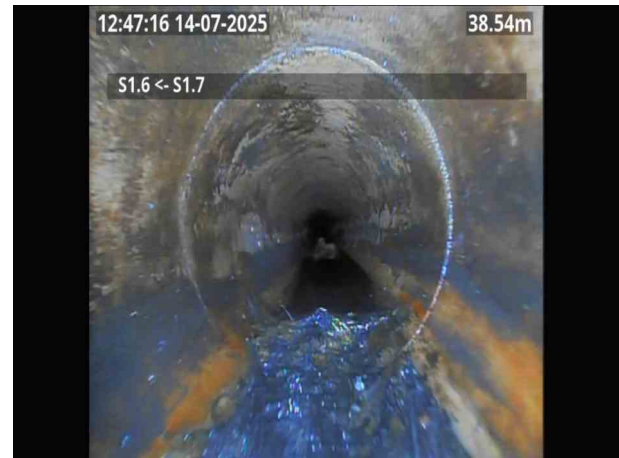
S1.6X_77c98f29-0388-4d0c-83f4-03005816b0a3_20250715_134346_511.jpg, 00:02:58, 38.55 m
Settled deposits, hard or compacted, 15% cross-sectional area loss

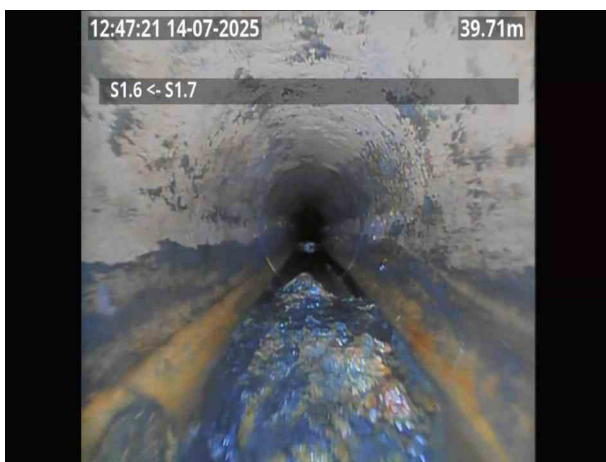
S1.6X_73176655-aae3-438f-b26c-d793b7841327_20250715_134357_875.jpg, 00:03:03, 39.74 m
Settled deposits, hard or compacted, 20% cross-sectional area loss

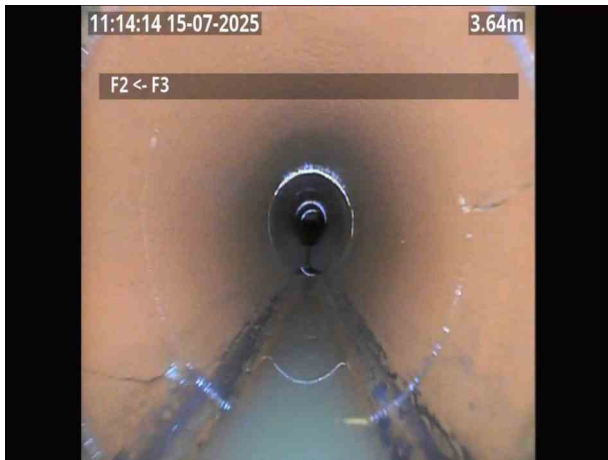
| No. | m+ | Code | Observation |
|---|---|---|---|
| 4 | 3.68 | FLJ | Fracture, longitudinal at joint at 3 o'clock |

F2X_2c704cc1-e789-432b-be01-d95e629f4709_20250715_162516_134.jpg, 00:00:29, 3.68 m
Fracture, longitudinal at joint at 3 o'clock

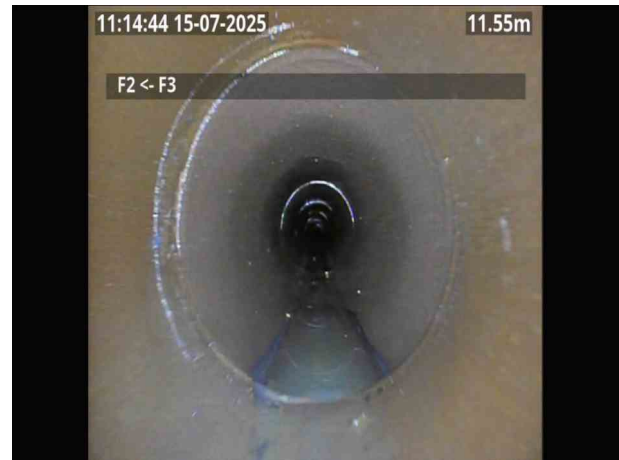
| No. | m+ | Code | Observation |
|---|---|---|---|
| 6 | 11.55 | FCJ | Fracture, circumferential at joint from 7 o'clock to 12 o'clock |

F2X_24fa8d23-09b1-47c7-b50d-393e81cf9de0_20250715_162613_033.jpg, 00:00:59, 11.55 m
Fracture, circumferential at joint from 7 o'clock to 12 o'clock
