Project**Project Name:** ARRIVA ST HELENS JN-CW-7734**Project Date:** 01/07/2025**Inspection Standard:** MSCC5 Sewers & Drainage GB (SRM5 Scoring)

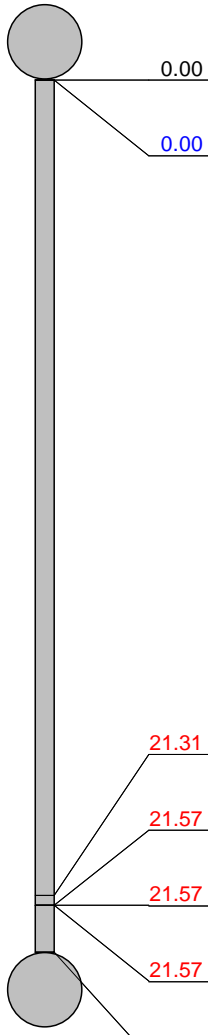
| Scale: | 1:198 | Position [m] | Code | Observation | MPEG | Photo | Grade |
|---|---|---|---|--|---|---|---|
| | | 21.31 | FC | Fracture, circumferential from 4 o'clock to 11 o'clock | 00:03:07 | F8X_60b6 ea5c-6835 -4b66-8df7 | 3 / 2 |
| | | 21.57 | FL | Fracture, longitudinal at 6 o'clock | 00:03:10 | F8X_bccc a670-a999 -44fb-9e4f- | 3 / 2 |
| | | 21.57 | FS | Fracture, spiral from 7 o'clock to 8 o'clock | 00:03:10 | F8X_5d12 dc2e-1556 -44b6-b0f8 | 4 / 2 |
| | | 21.57 | FLJ | Fracture, longitudinal at joint at 12 o'clock | 00:03:10 | | 3 / 2 |

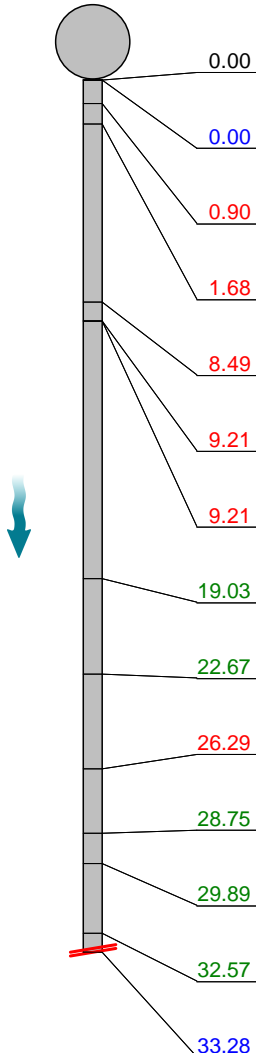
| Scale: | 1:289 | Position [m] | Code | Observation | MPEG | Photo | Grade |
|---|---|---|--|---|---|---|---|
| | 0.90 | CC | Crack, circumferential from 9 o'clock to 3 o'clock | | 00:00:21 | F3X_9614 26f9-a001- 4769-bea9 | 2 / 2 |
| | 1.68 | FCJ | Fracture, circumferential at joint from 9 o'clock to 3 o'clock | | 00:00:36 | F3X_5403 d241-f452- 4c07-aec5 | 3 / 2 |
| | 8.49 | CCJ | Crack, circumferential at joint from 8 o'clock to 12 o'clock | | 00:01:34 | F3X_bde3 0e6a-650f- 4065-b883 | 2 / 2 |
| | 9.21 | CCJ | Crack, circumferential at joint from 1 o'clock to 4 o'clock | | 00:01:36 | | 2 / 2 |
| | 9.21 | CLJ | Crack, longitudinal at joint at 11 o'clock | | 00:01:36 | F3X_2e39 e058-68f0- 44c6-aecb | 2 / 2 |
| | 26.29 | FCJ | Fracture, circumferential at joint from 11 o'clock to 2 o'clock | | 00:02:44 | | 3 / 2 |
